Re: August 2013 Monthly Progress Report
Administrative Settlement Agreement and Order on Consent for Removal Action
U.S. EPA Region 10 Docket No. CERCLA 10-2009-0255
Gasco Sediments Site within the Portland Harbor Superfund Site

Attachment A Monthly Visual Monitoring Report for Pilot Cap Vicinity

Visual Observations Log Form

Monitoring Period: Monthly (Year 7)—August 2013

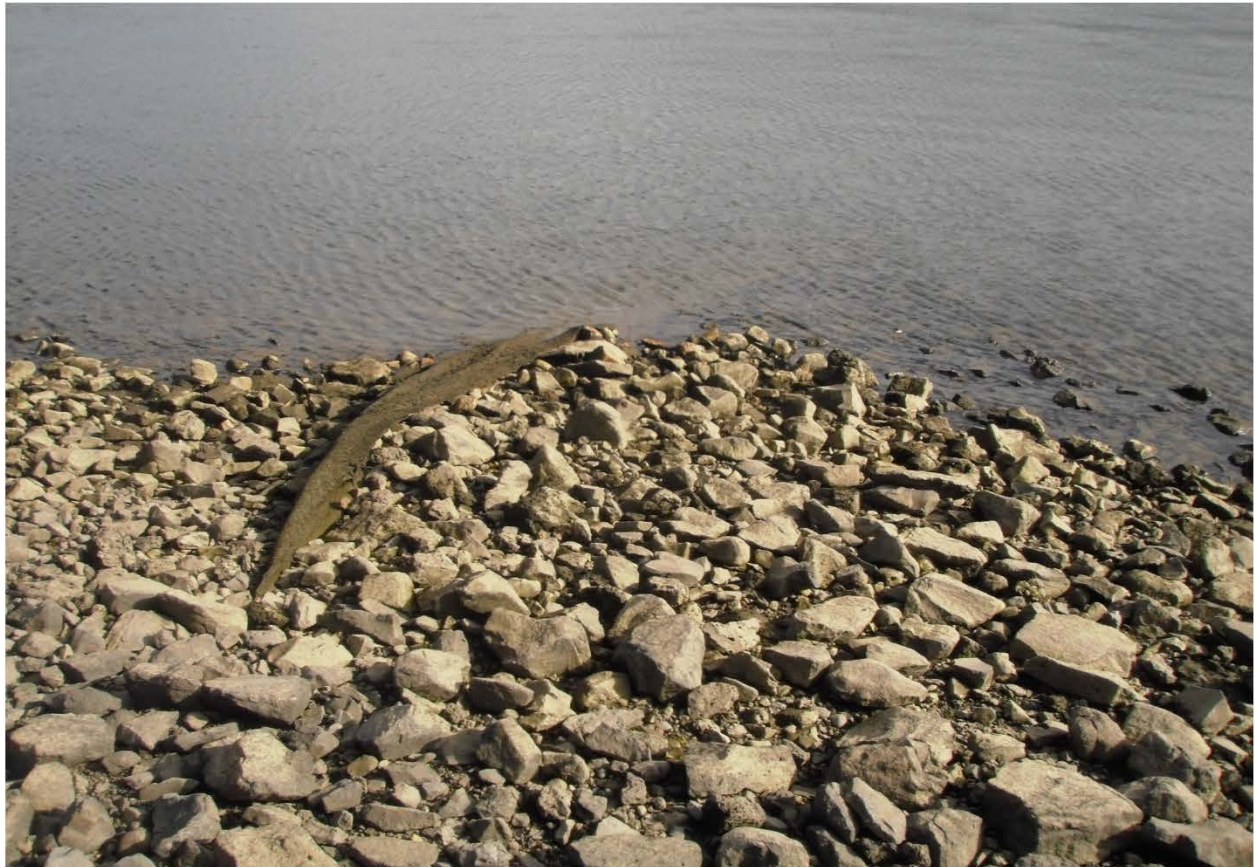
Observations of Erosion/Deposition: No erosion/deposition is evident along the shoreline. Three organoclay mat material segments are exposed and visible. Six feet of a 20-foot section of organoclay mat is out of the water at the upriver extent of the cap area (perpendicular to the shoreline). A segment measuring 4-foot in length is two feet from shoreline near the lateral mid-point of the cap area. One 40-foot section of organoclay mat material is exposed and submerged beneath 0-3 feet of water near the downriver extent of the cap area (Photo 1).

Photo 1 — *Visible section of organo-clay mat near the upriver extent of the cap area (2/26/13):*

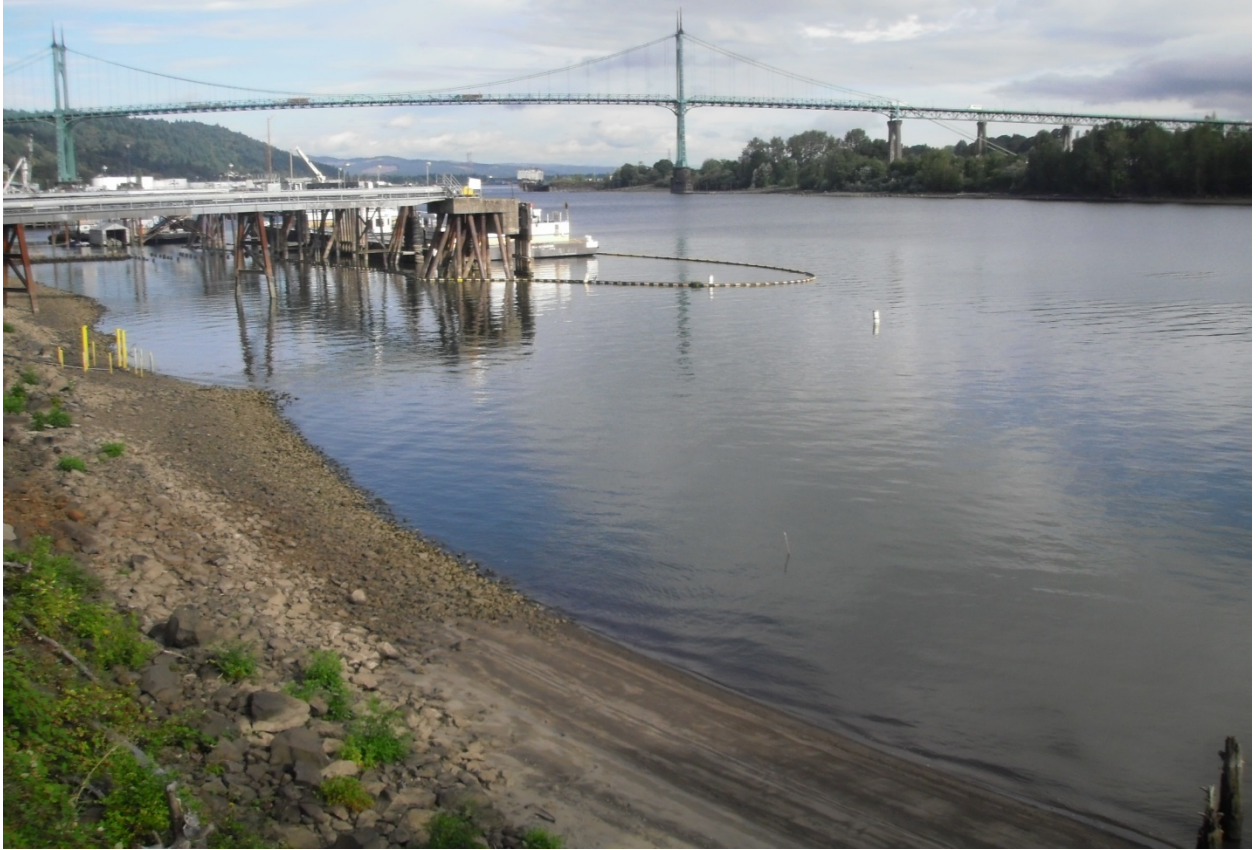
Observations of Long-term Controls (i.e., oil booms, organo-clay mat, etc.) During the observation, a barge was tied at the pier and the Fuel and Marine Marketing (FAMM) containment boom was placed around the barge during refueling operations. Buoys that identify the cap area to mariners are in place as installed. The position of the FAMM oil boom, warning buoys, and a general overview is shown in Photo 2.

Photo 2 — *FAMM oil boom around barge and mariner warning buoys across pilot cap area. (8/26/13):*

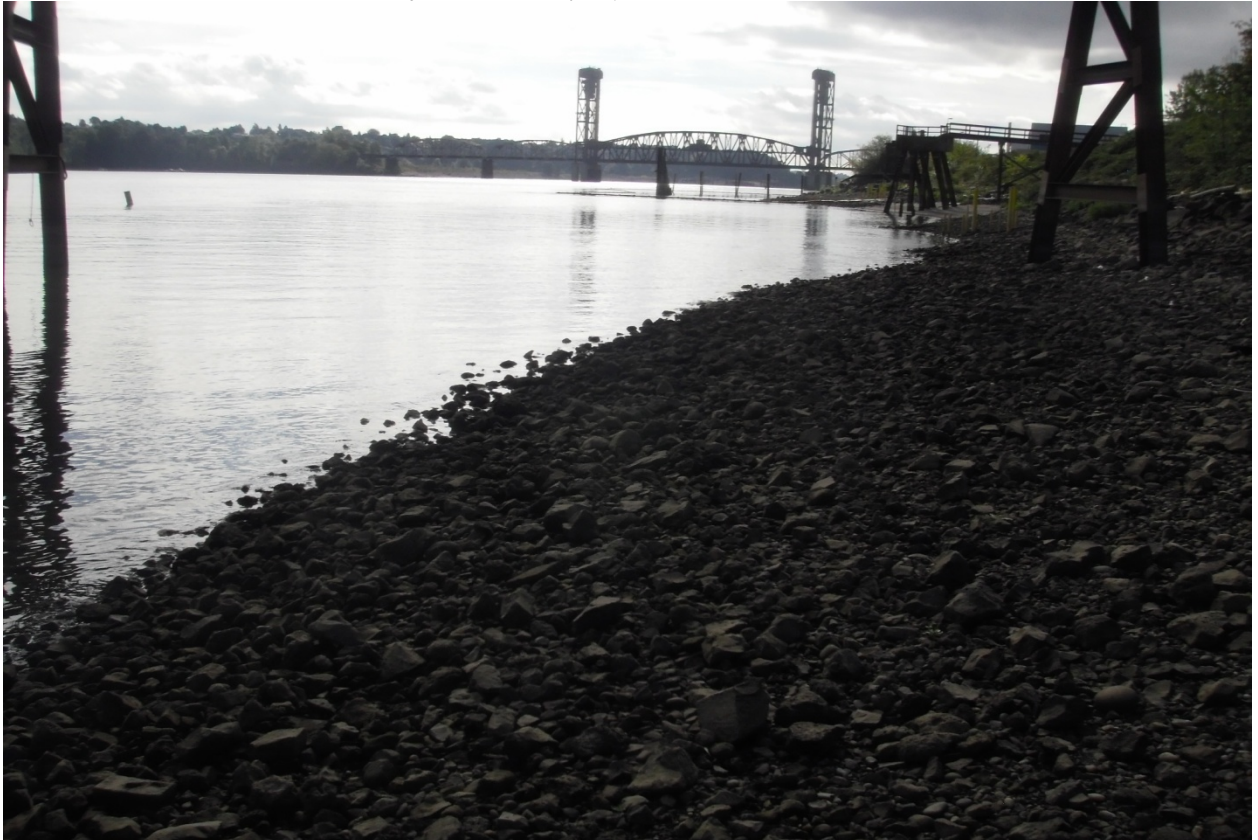
No sheen is evident in or around the cap area. Photo 3 shows the water surface and shoreline immediately downriver of the sediment cap.

Photo 3 — *Conditions immediately downriver of cap area (8/26/13):*
